Flood Control Project Maintenance
2008 Structure Summary Report
Overall Unit and Item Ratings

DWR Sutter Maintenance Yard

2008 Structure Inspection Results

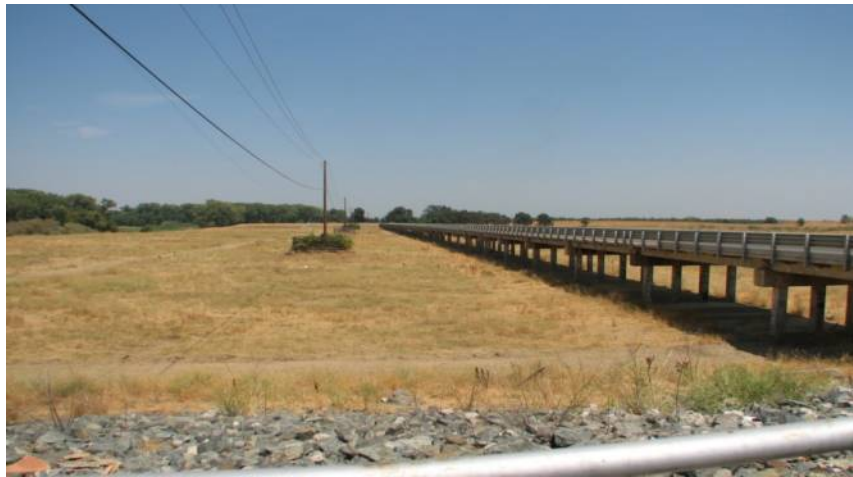
Report Line	1
Location	
Category	Structures & Concrete Lined Channels
Item	Vegetation & Obstructions

The upstream side of weir from the south levee

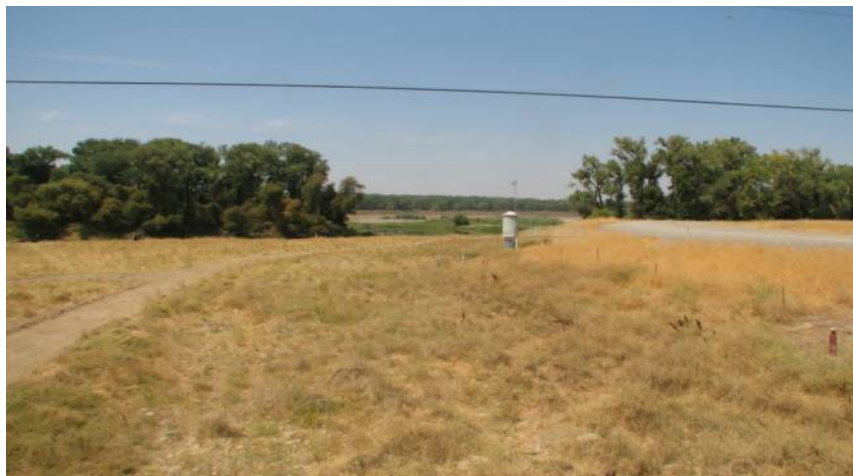
Report Line	2
Location	
Category	Structures & Concrete Lined Channels
Item	Vegetation & Obstructions

View of the gauging house, Sacramento River in the background

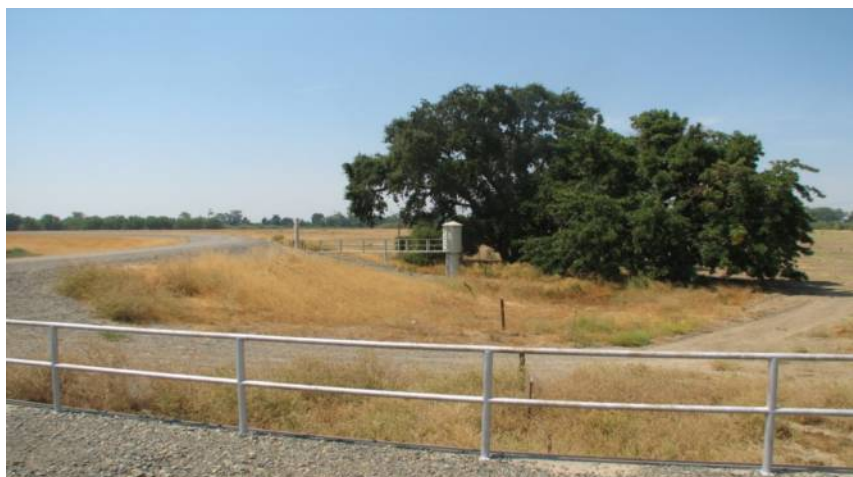
Report Line	3
Location	
Category	Structures & Concrete Lined Channels
Item	Vegetation & Obstructions

View of the gauging house directly upstream of weir

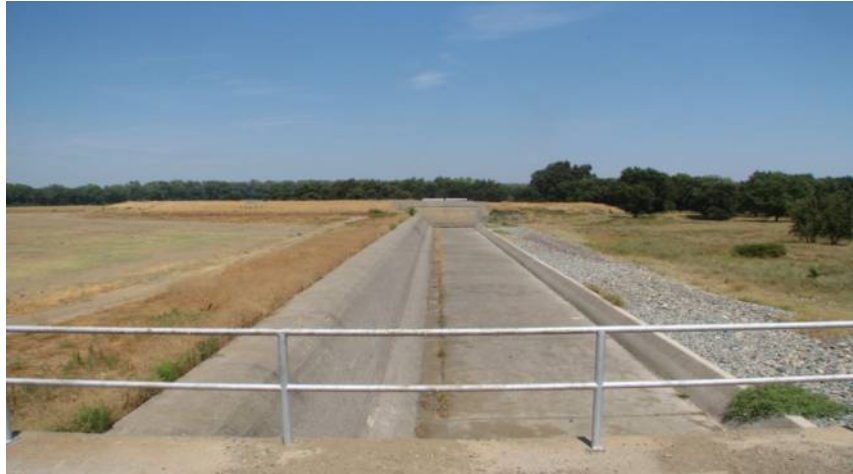
Report Line	4
Location	
Category	Structures & Concrete Lined Channels
Item	Concrete Foundations

The weir and stilling basin from the top of the south abutment

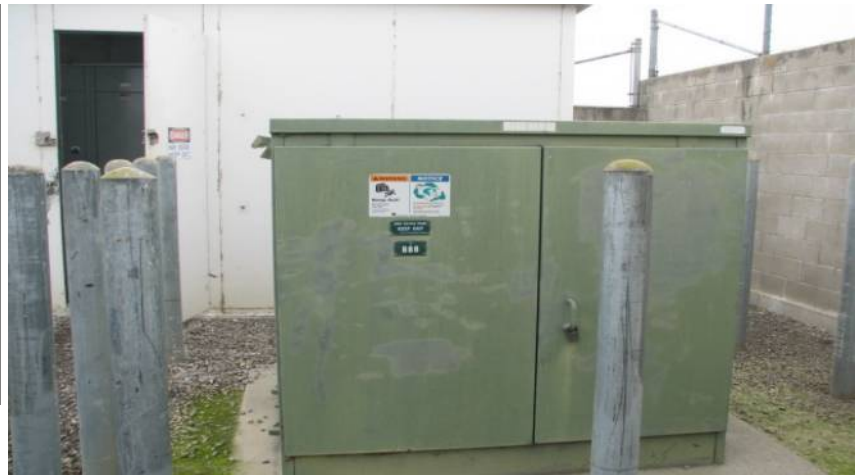
Report Line	8
Location	
Category	Pump Stations
Item	Power
Secured power supply.

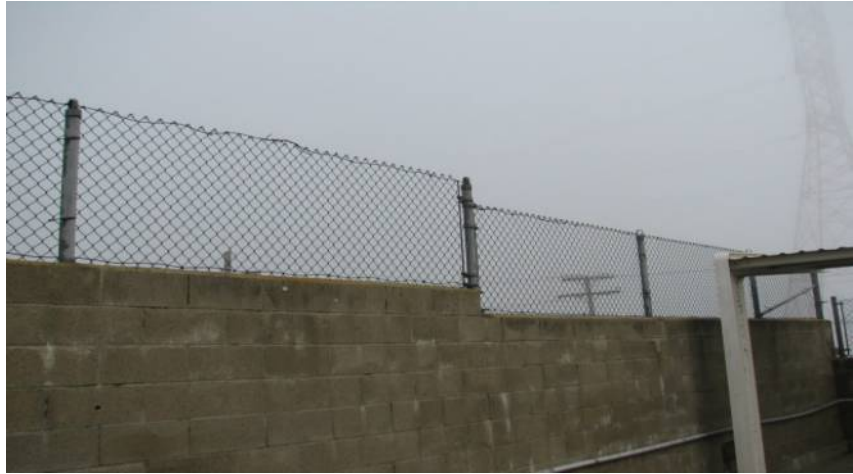
Report Line	20
Location	
Category	Pump Stations
Item	Security Fencing

View of security fencing attached to the top of all enclosing walls.

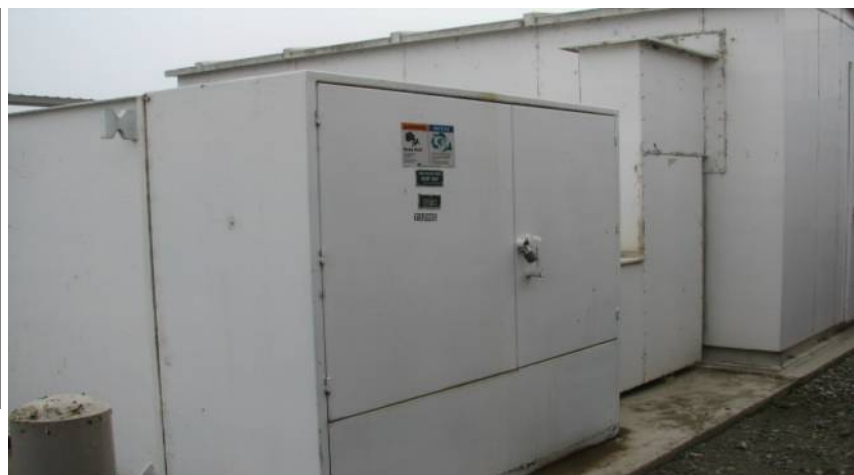
Report Line	8
Location	
Category	Pump Stations
Item	Power

Power source is secured and reliable provided no outages occur.

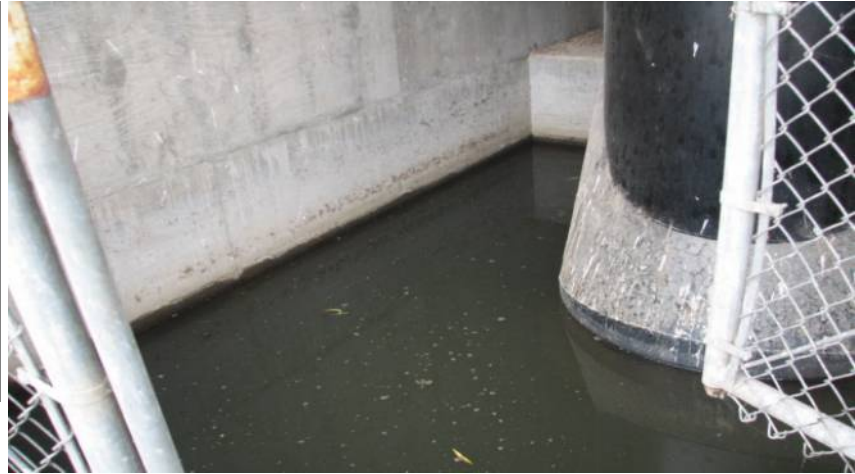
Report Line	11
Location	
Category	Pump Stations
Item	Sumps/Wet Well

Wet wells are kept clear of debris.

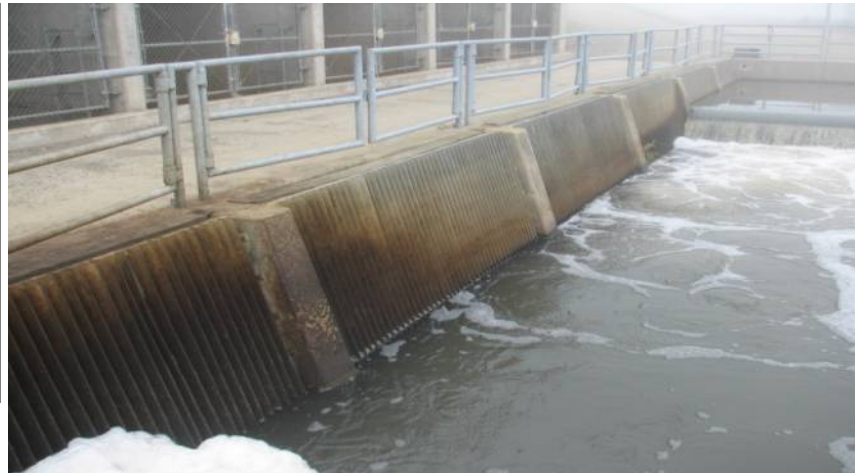
Report Line	12
Location	
Category	Pump Stations
Item	Trash Racks

Trash racks are clear and functional.

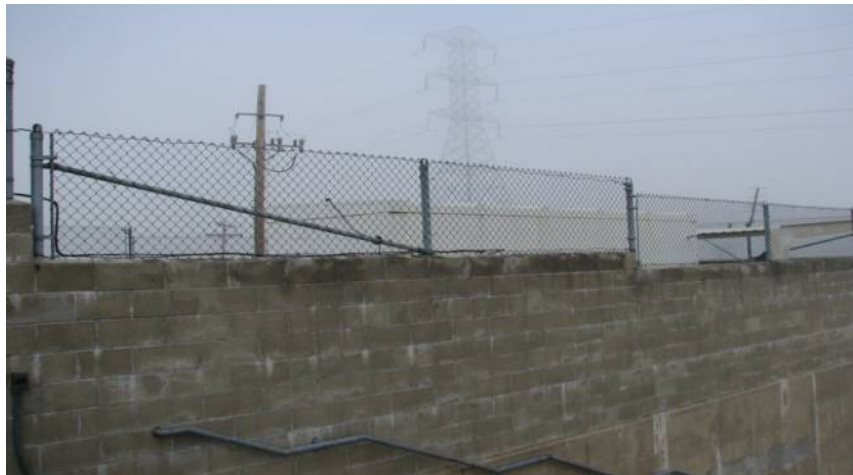
Report Line	20
Location	
Category	Pump Stations
Item	Security Fencing

Typical view of fencing attached to the top of all surrounding walls.

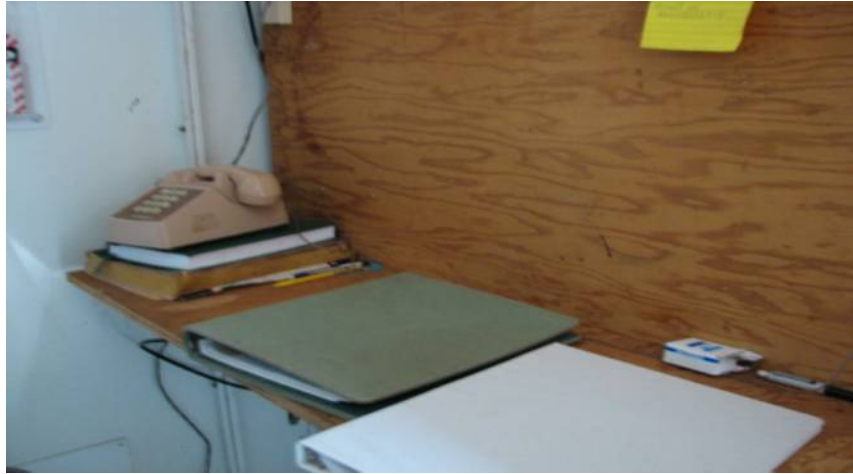
Report Line	1
Location	
Category	Pump Stations
Item	Operating Log

Operating log is kept on site.

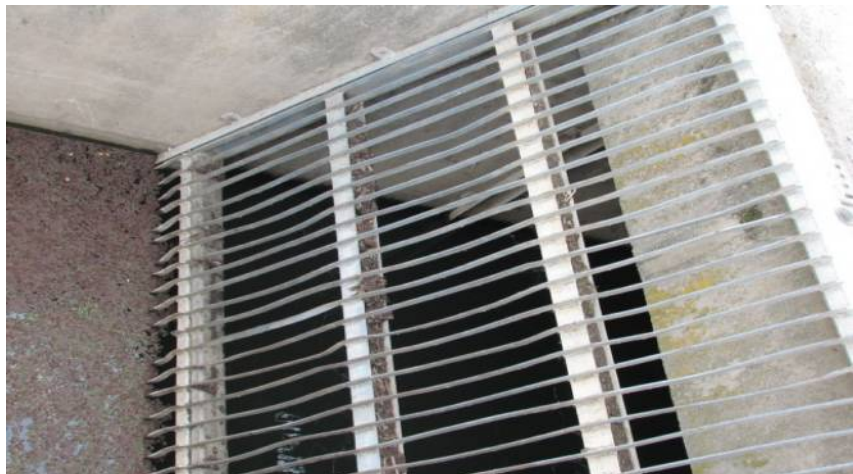
Report Line	12
Location	
Category	Pump Stations
Item	Trash Racks

Trash racks are kept clear of debris and function well.

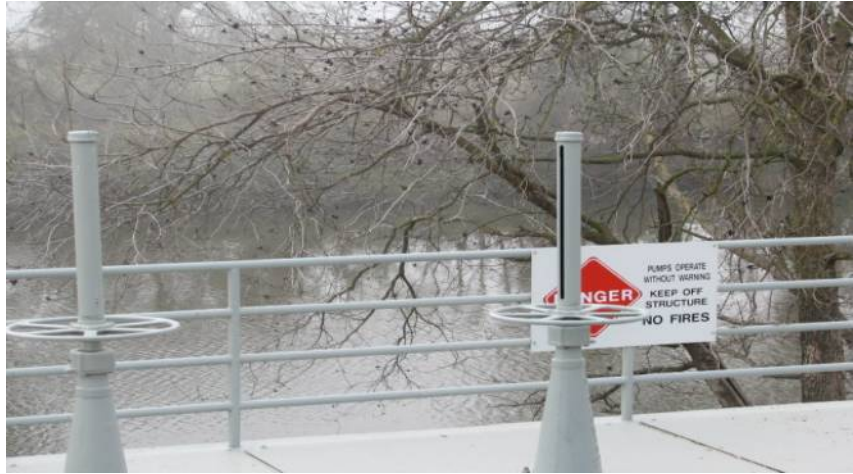
Report Line	16
Location	
Category	Pump Stations
Item	Manual Gate Operators

Manually operated slide gates are at the discharge side.

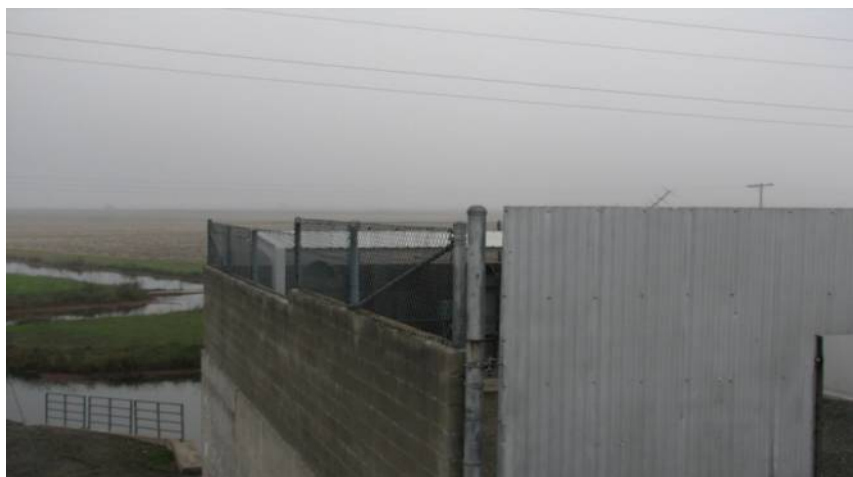
Report Line	20
Location	
Category	Pump Stations
Item	Security Fencing

View of security fencing.

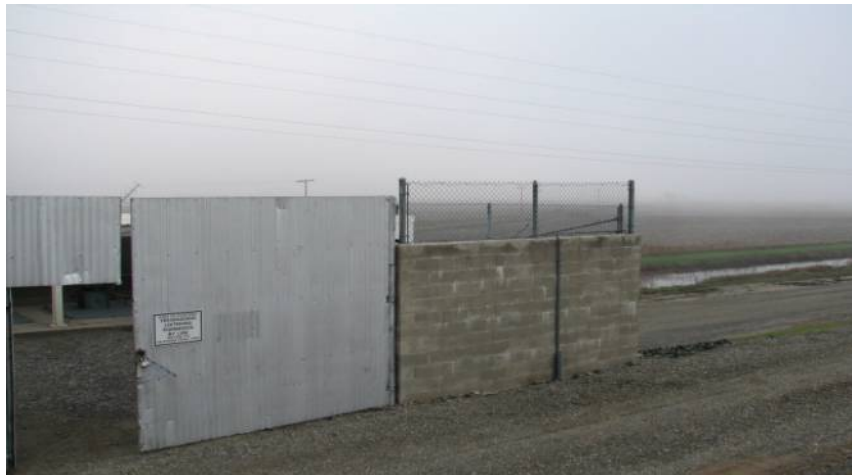
Report Line	20
Location	
Category	Pump Stations
Item	Security Fencing

Another view of security fencing.

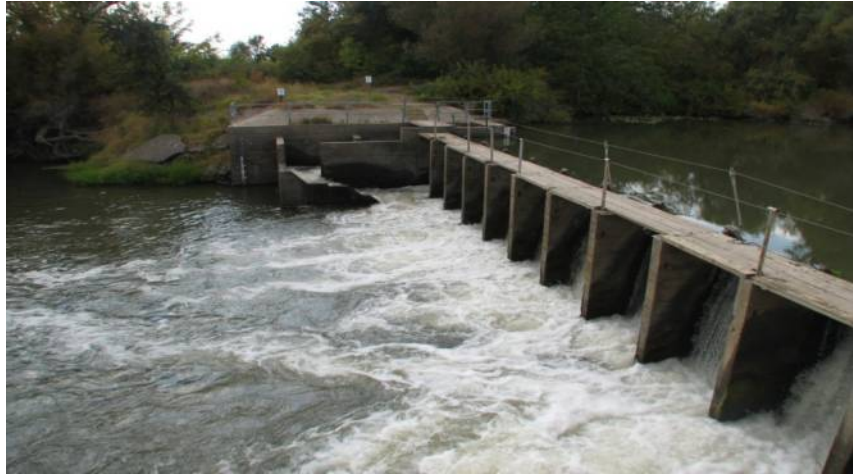
Report Line	1
Location	
Category	Structures & Concrete Lined Channels
Item	Concrete Foundations

Downstream side of the structure.

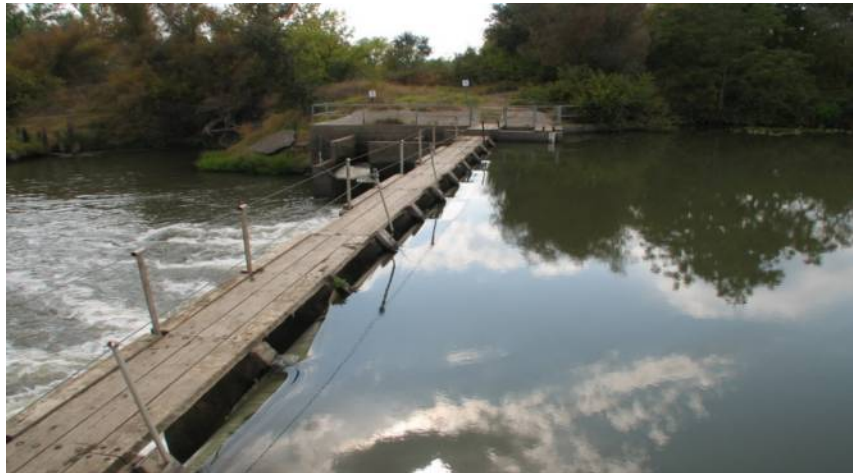
Report Line	2
Location	
Category	Structures & Concrete Lined Channels
Item	Concrete Foundations

Upstream side of the structure.

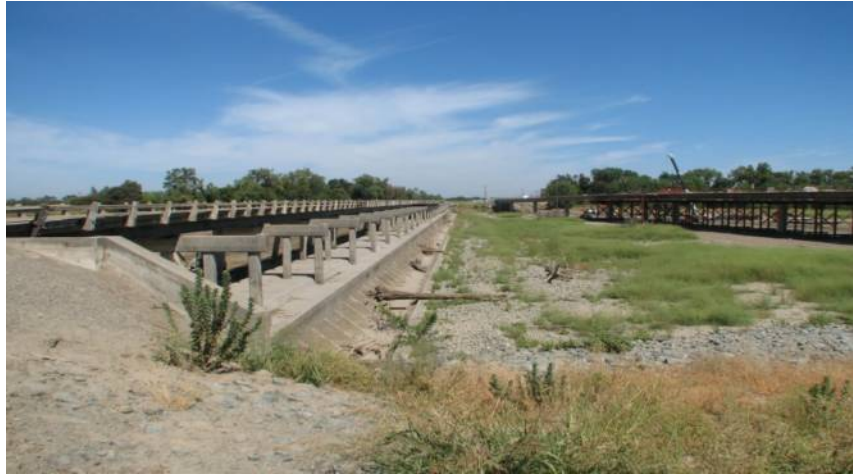
Report Line	1
Location	
Category	Structures & Concrete Lined Channels
Item	Concrete Foundations

Upstream side of the weir from the south end.

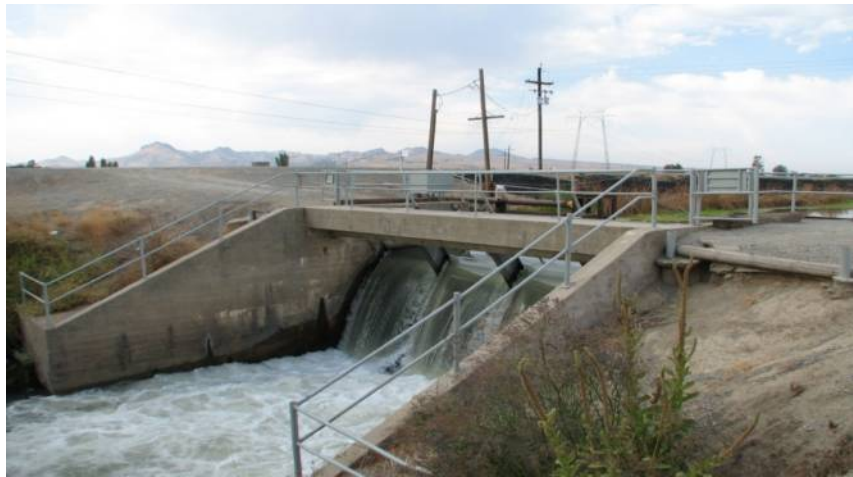
Report Line	1
Location	
Category	Structures & Concrete Lined Channels
Item	Concrete Foundations

View of the downstream side of structure.

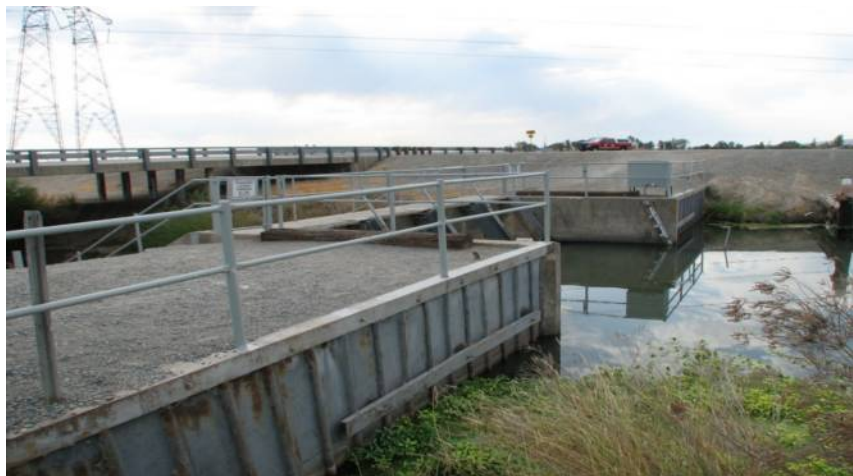
Report Line	2
Location	
Category	Structures & Concrete Lined Channels
Item	Concrete Foundations

Upstream side of structure from the left bank levee.
